# Remedy Effectiveness: Comparison of Remediation Technologies

## Thin Layer Dredging and Capping

## Recent Case Histories

William Elmer, PE, Foster Wheeler Environmental Corp

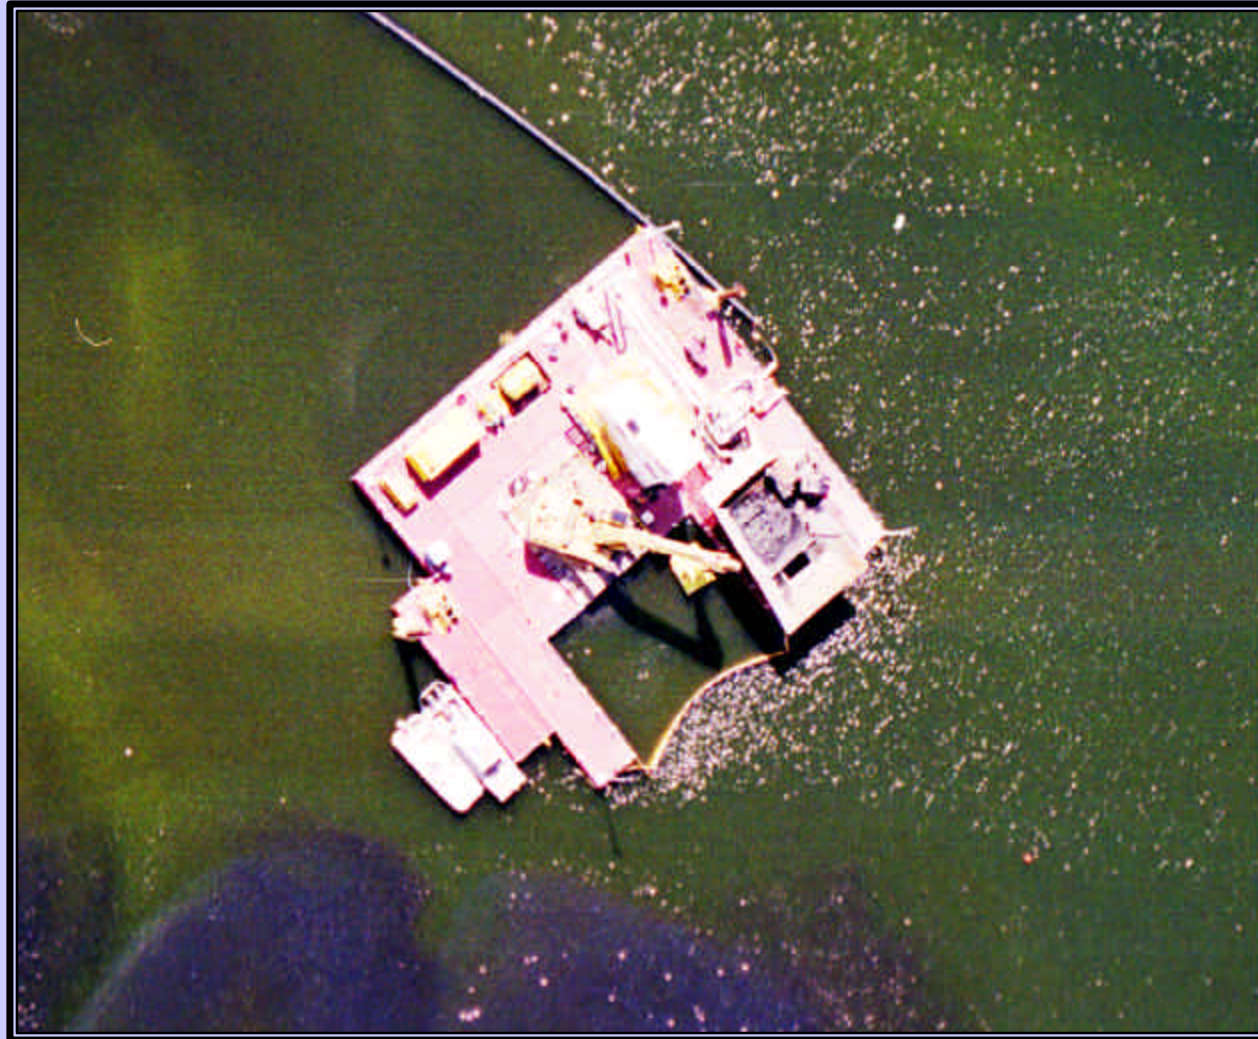
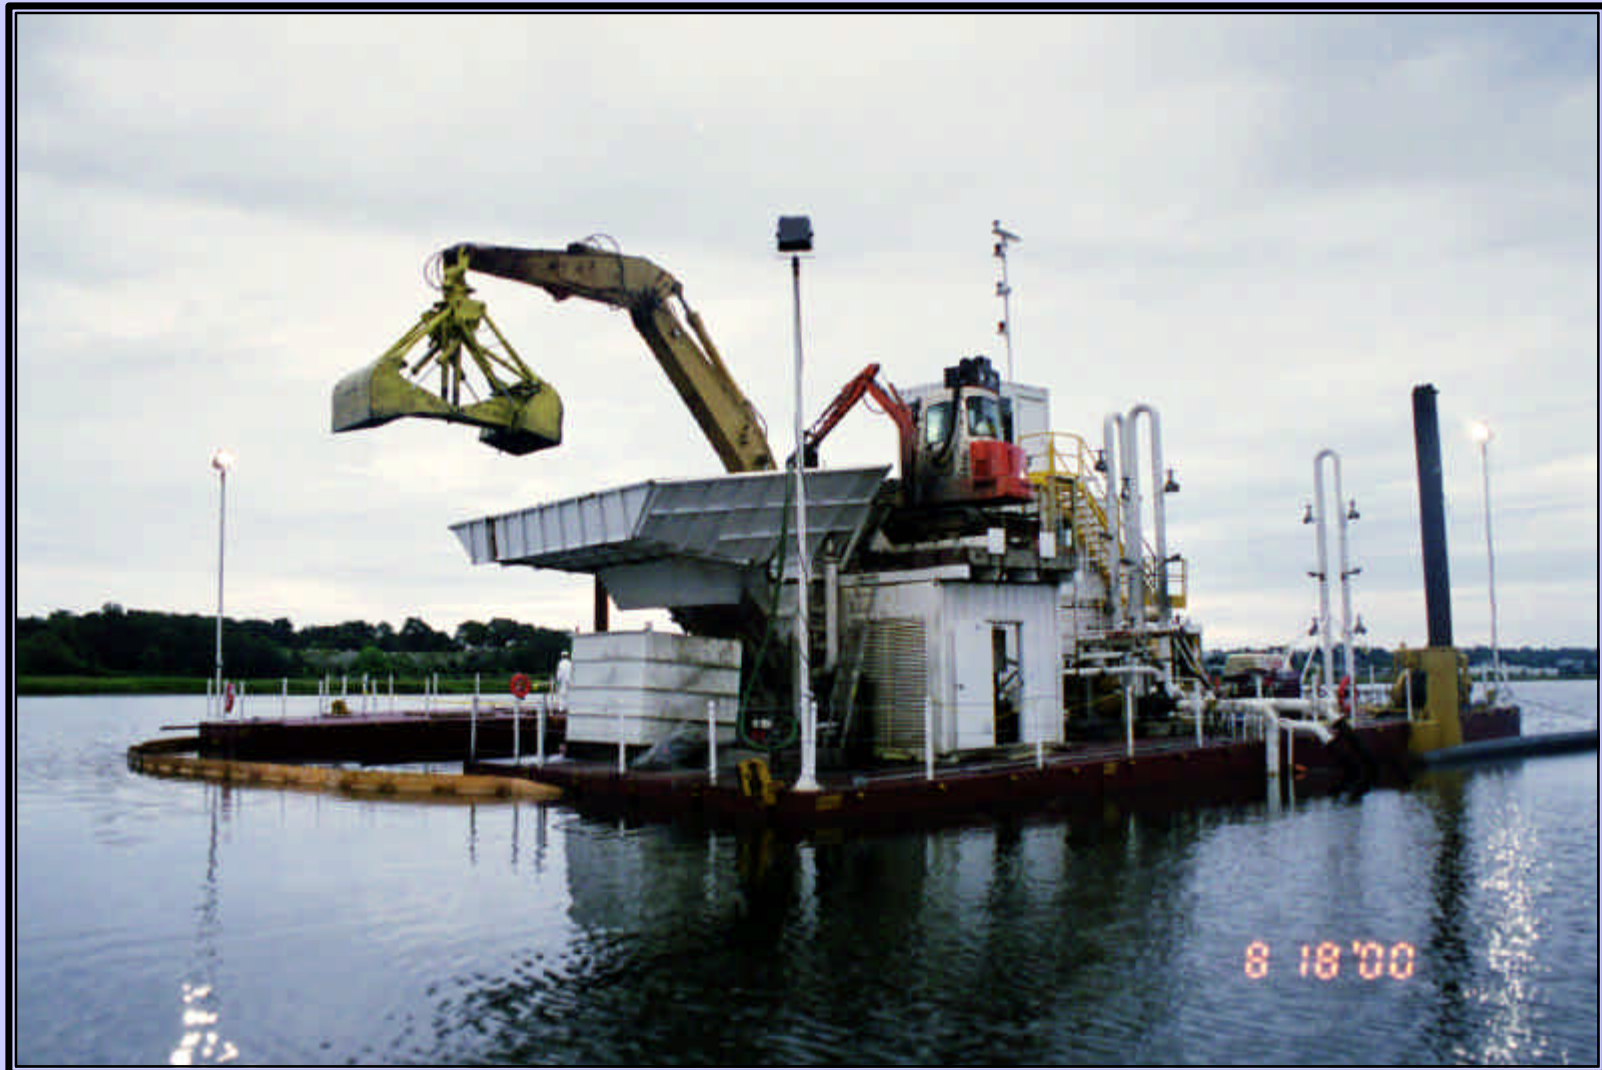
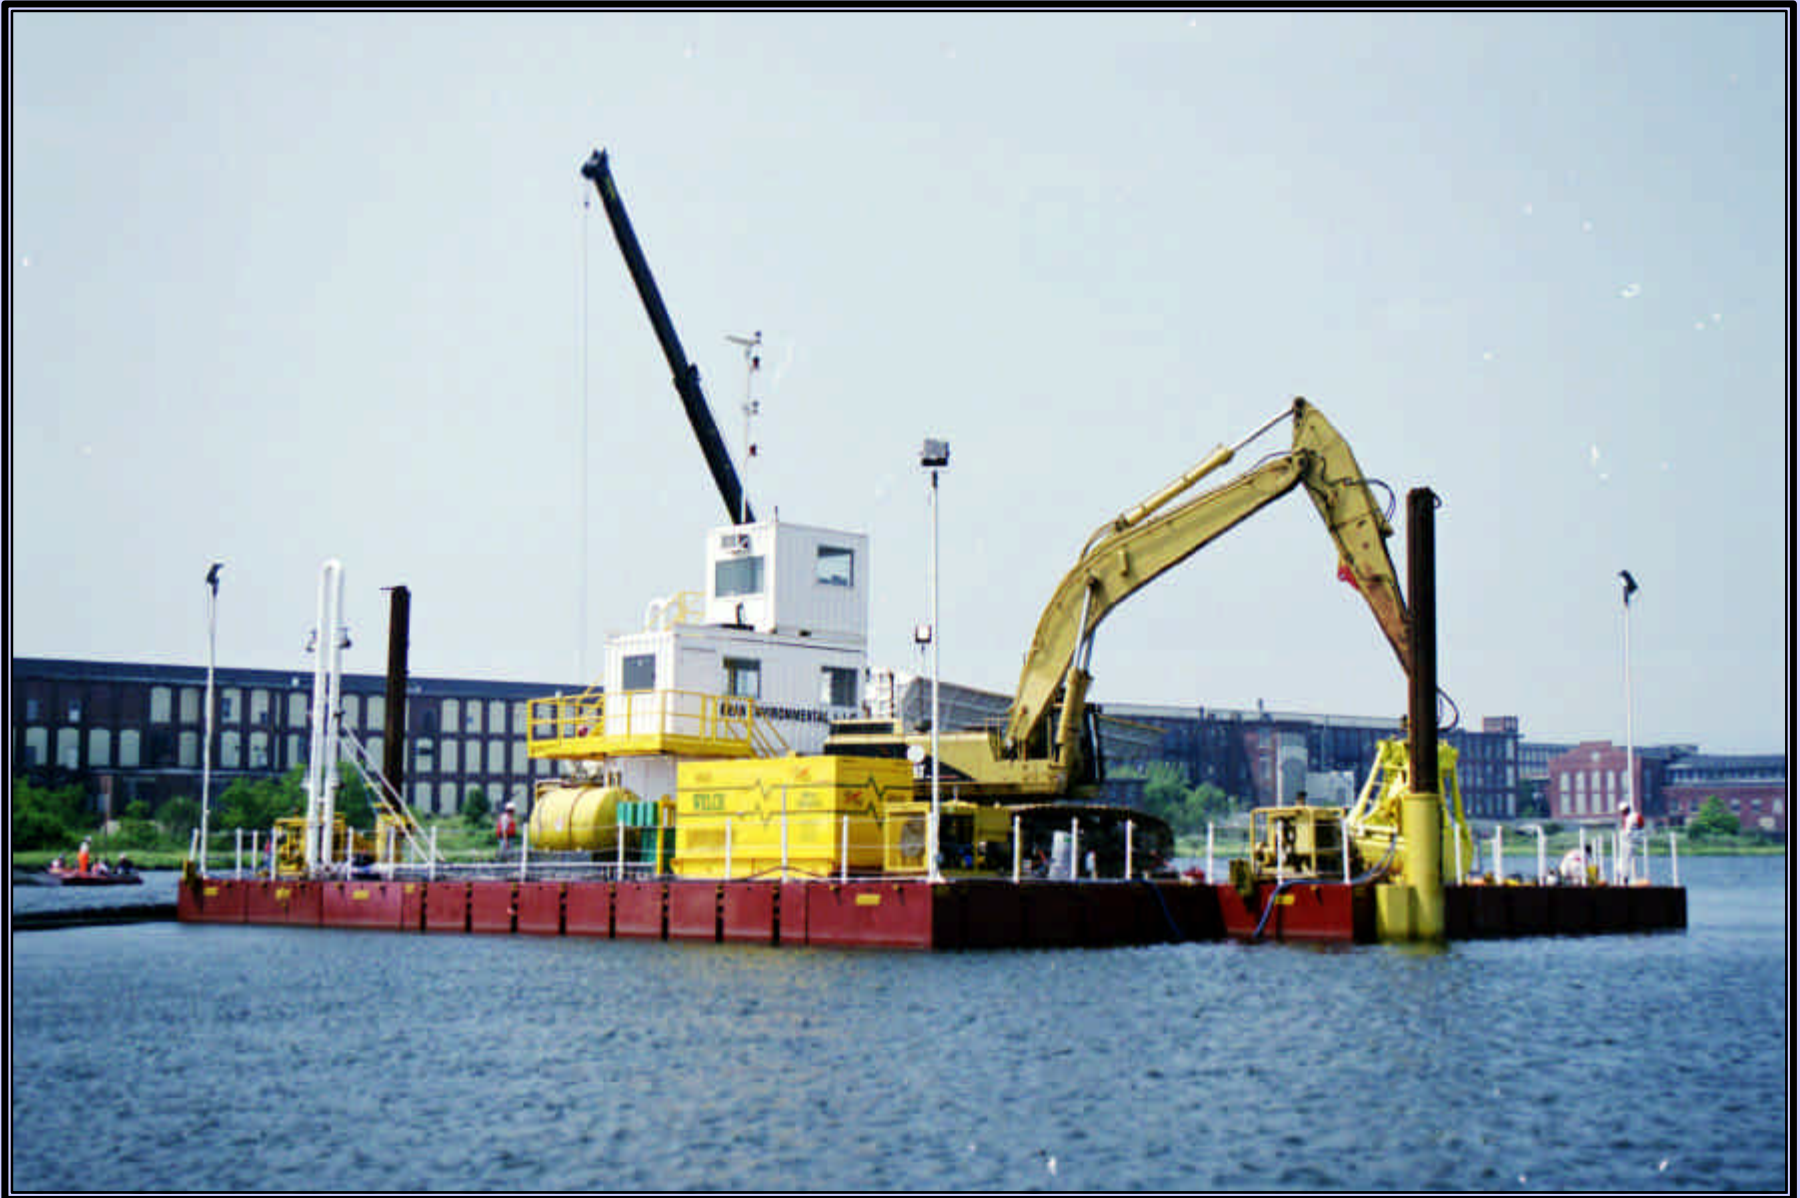
# BELLC Test Dredge

- Initial Plan (ROD) to Hydraulically Dredge
- Evaluated Several Alternative Systems (1999)
- Developed Concept of a Specialized Hybrid Dredge
  - Mechanical Excavator/Hydraulic Transport
  - Mounted on Modular Float System
  - Manufactured Off Site, Assembled on Site
- Bean Environmental LLC (BELLCC)  
Fabricated and Operated Specialized Hybrid System

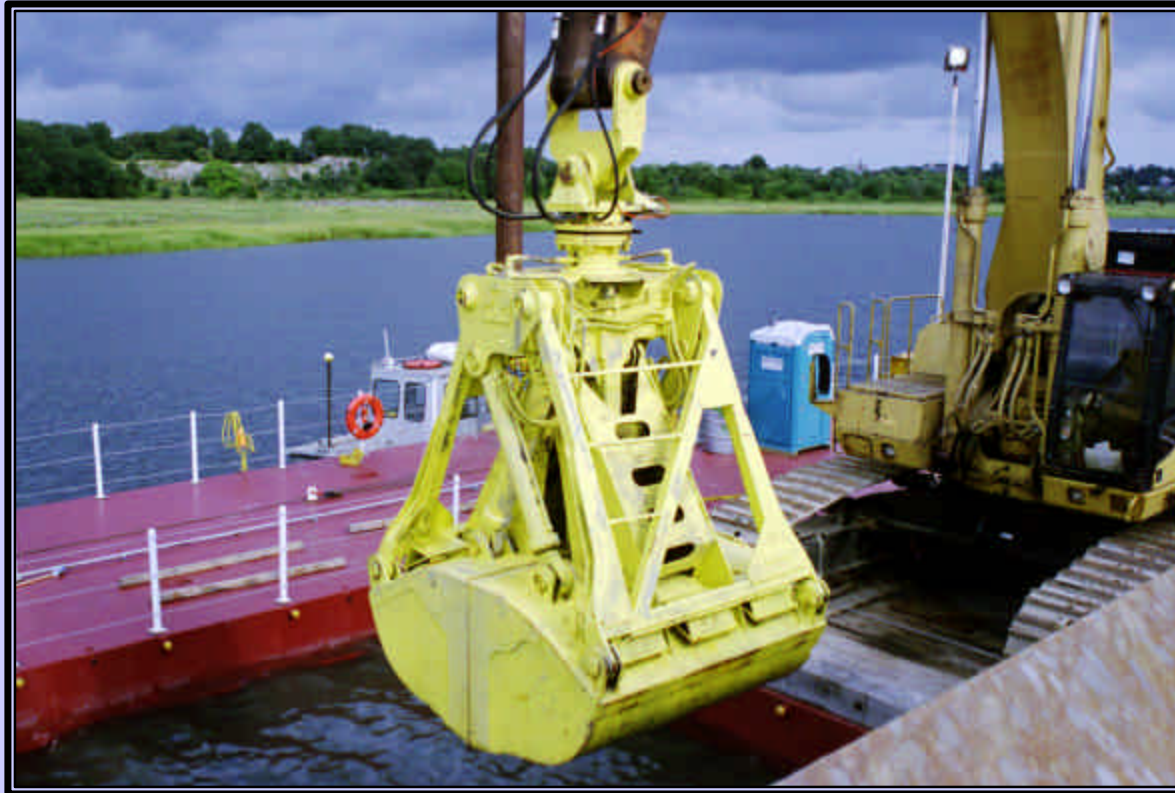
# Horizontal Profiling Grab Bucket

- 4.5 cy Bucket
- Full Range of Motion
- Hydraulic Closure
- Sealed Edges
- Level Cut

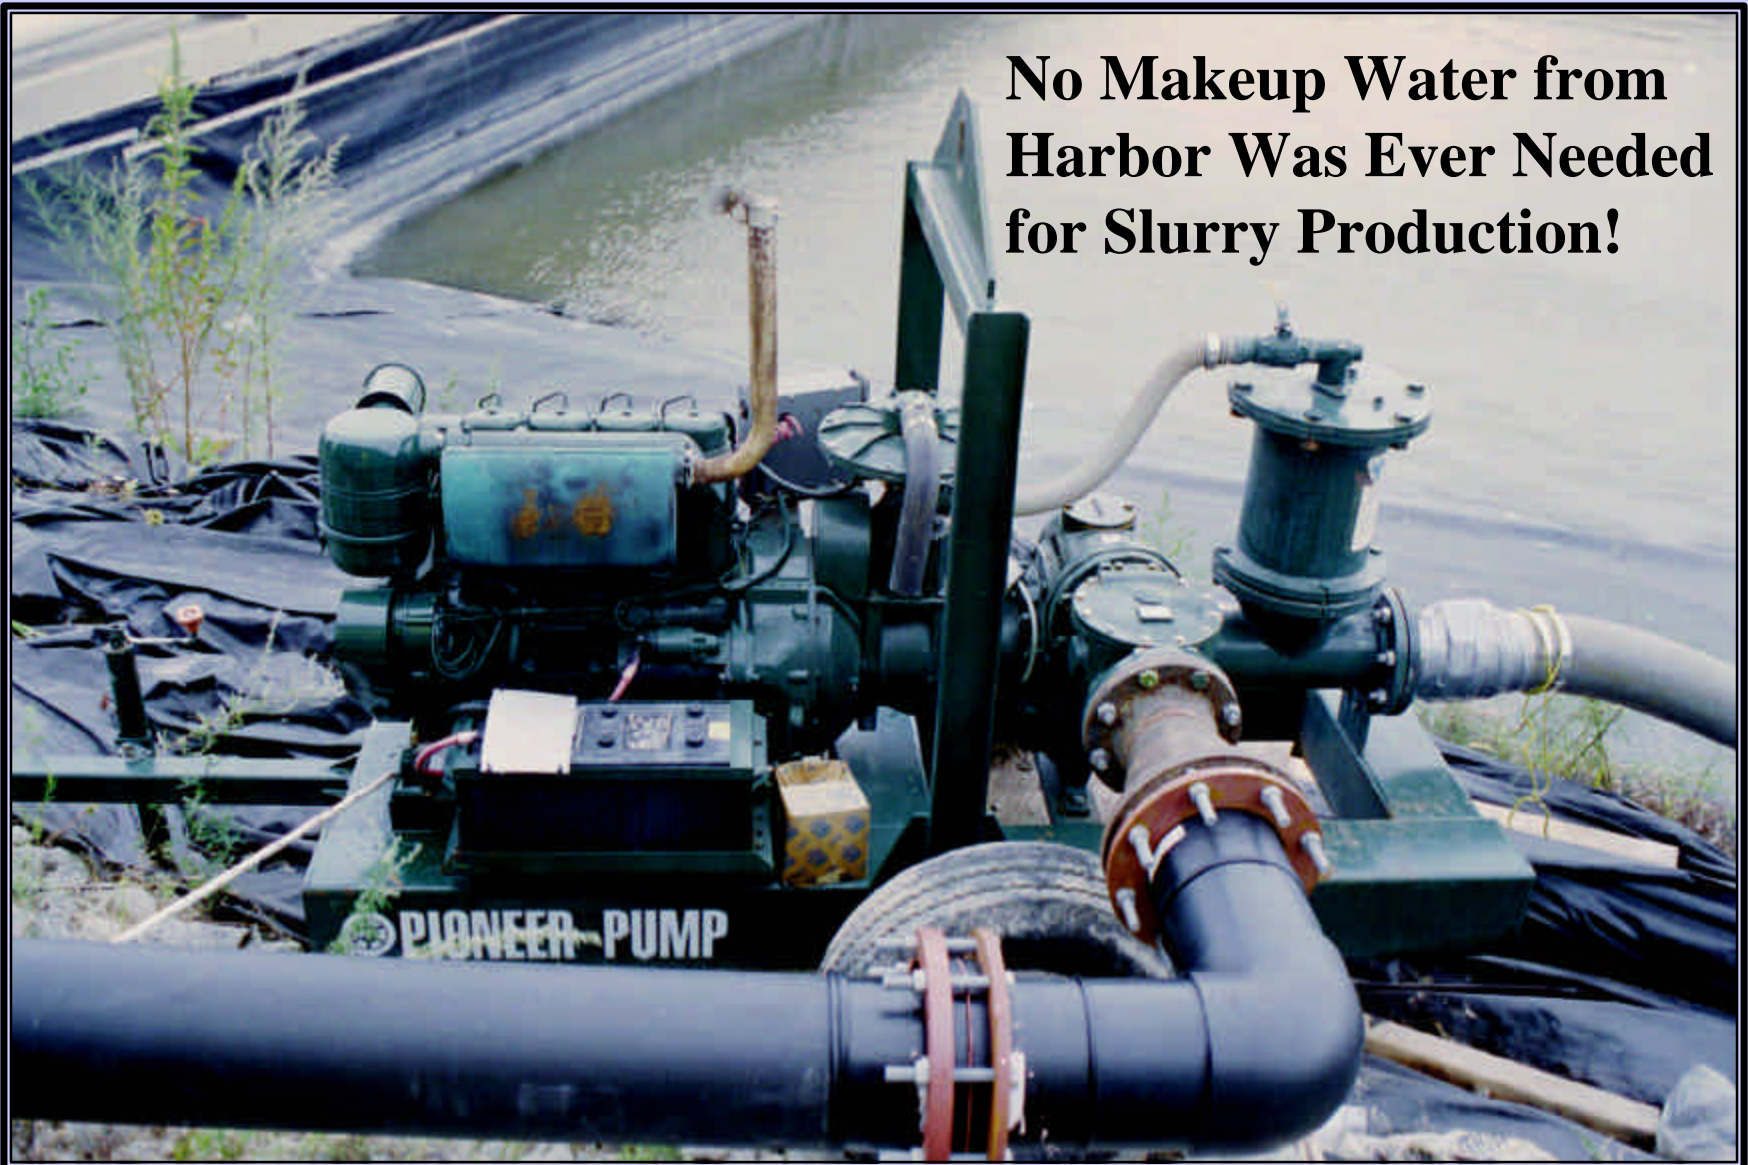
# Re-Circulation System

**No Makeup Water from Harbor Was Ever Needed for Slurry Production!**

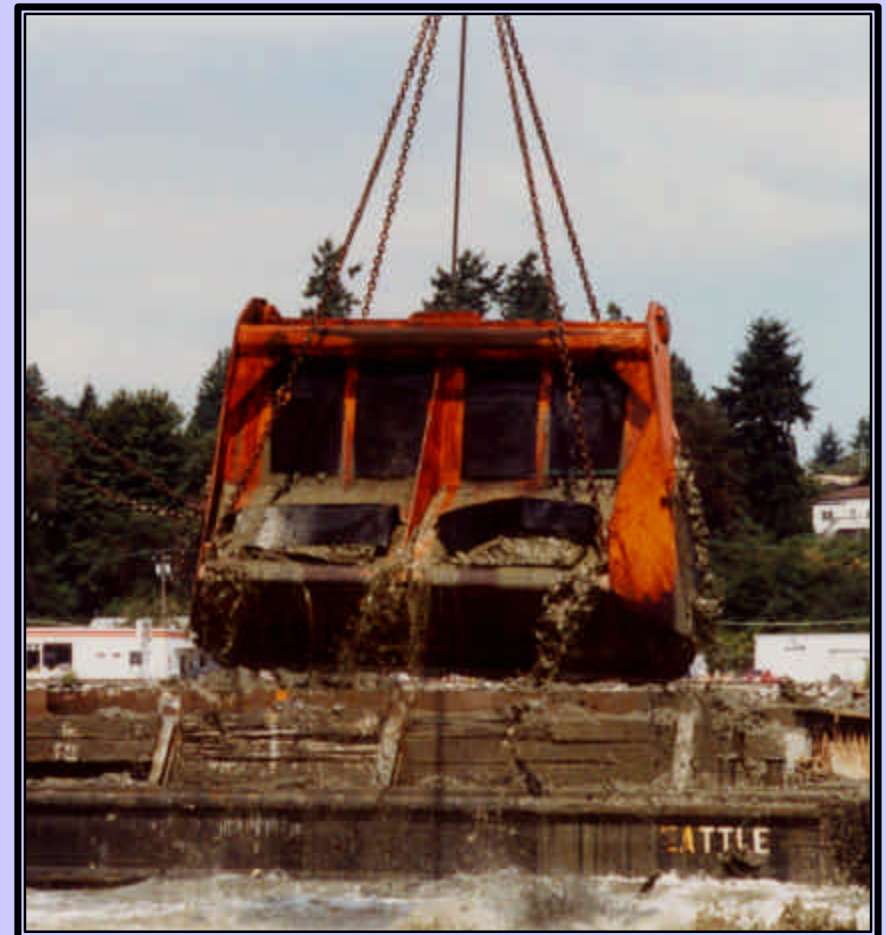
# Overfilling = Spills from Vents

Which Can result in  
Water Quality Problems
